Moreton Bay Rail Project

Independent Hydraulic Review

Prepared for: Department of Transport and Main
Roads
Date: 7 August, 2015

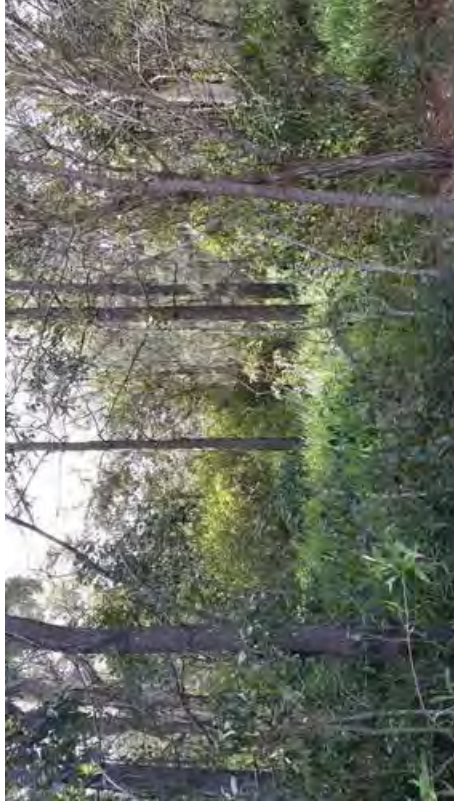
Saltwater Creek near Anzac Avenue (16/07/2015)

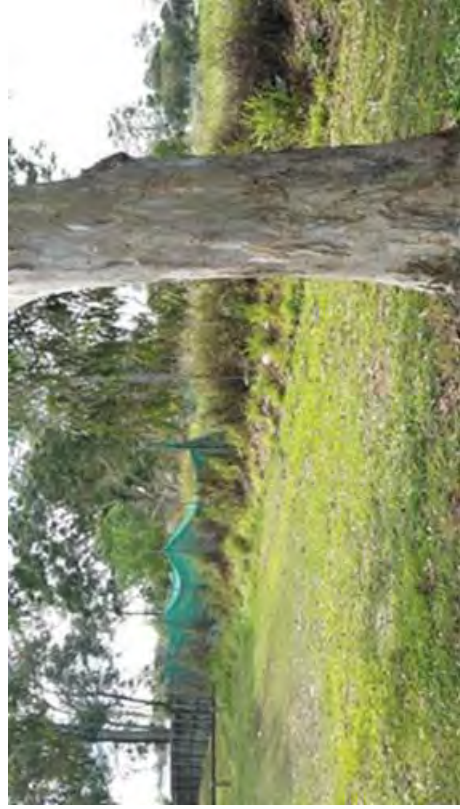
Fences near McGahey Street, Rothwell (16/07/2015)

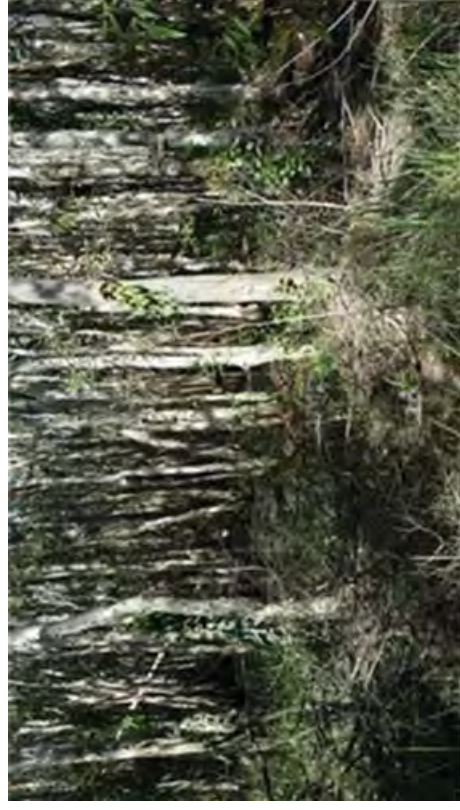
Saltwater Creek near Whitecedar Circuit (16/07/2015)

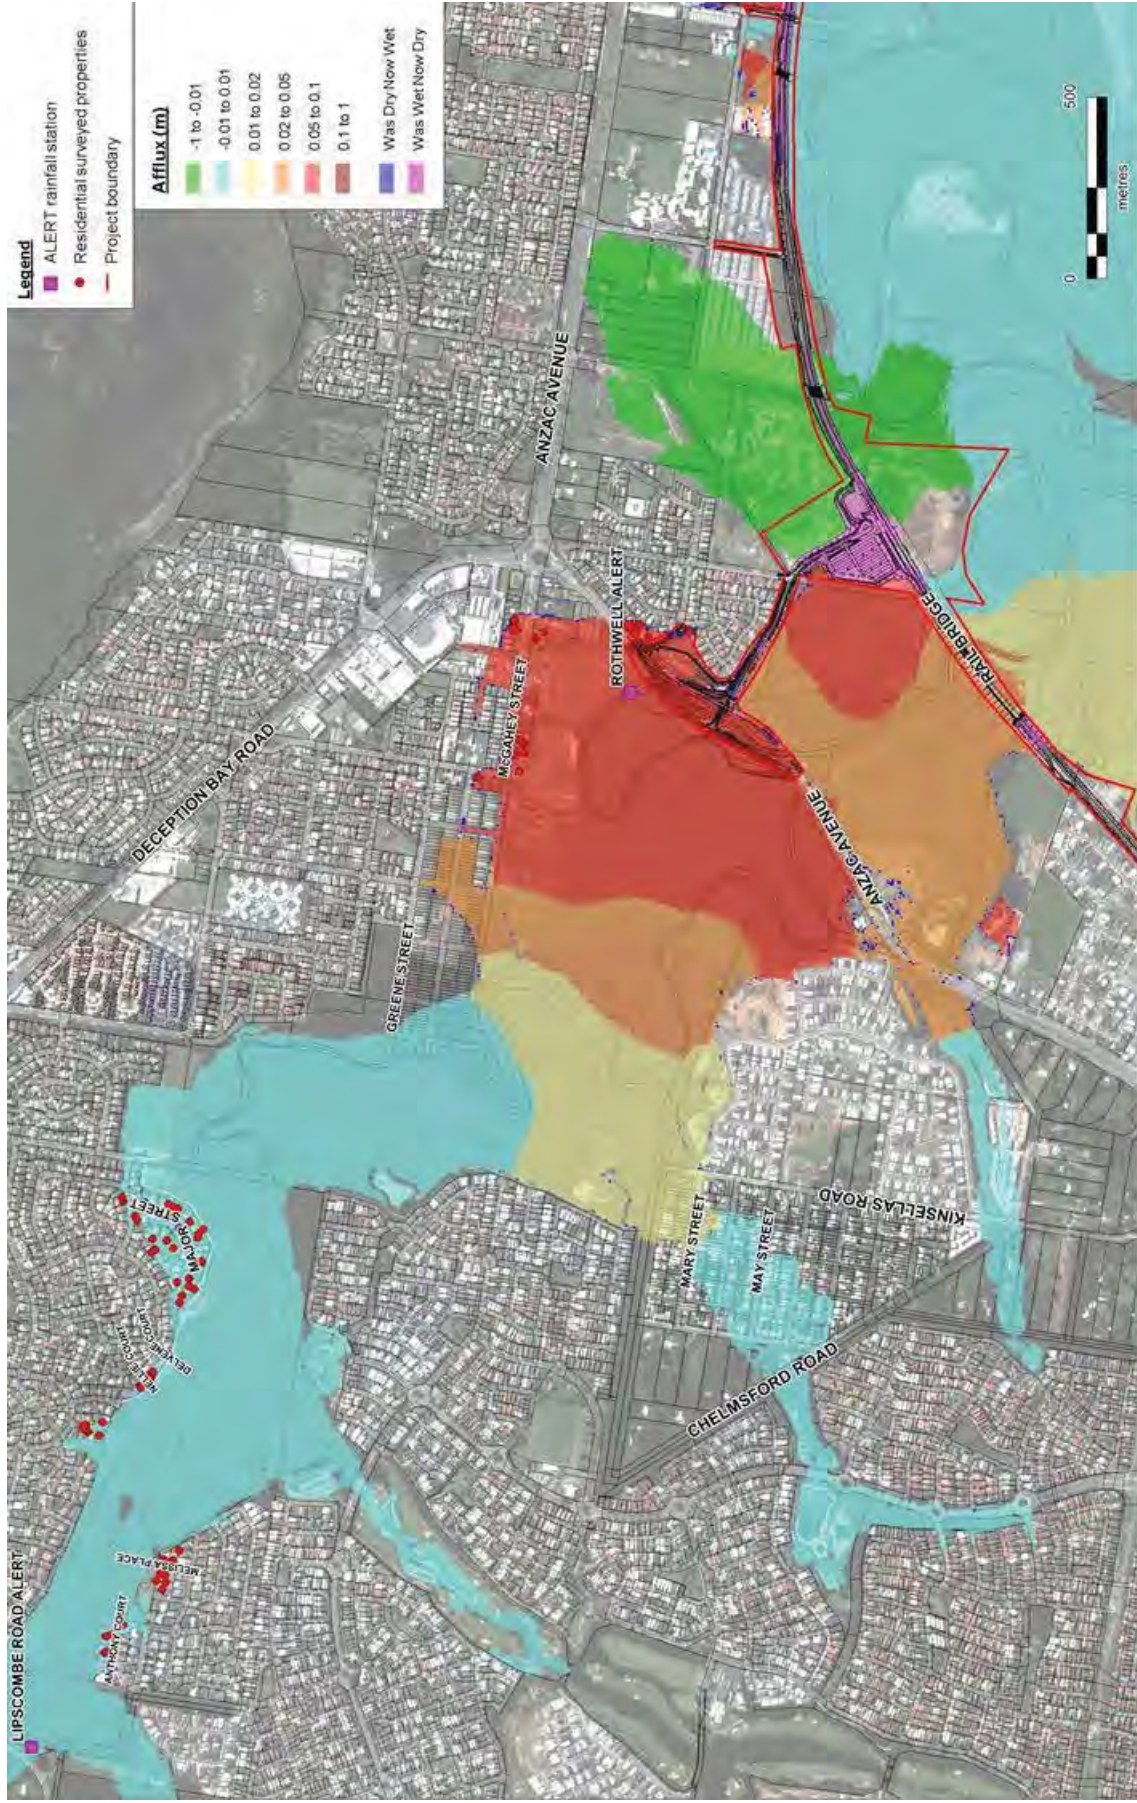
Figure 32 – Afflux, 1% AEP event, Developed vs Existing Base condition

It should be noted that 85 residential properties are located in the area where flood levels were increased by MBR works during the 1st May 2015 storm event and of these 49 were located in the area affected in the 1% AEP storm event. All of these properties would have experienced flooding on the 1st May 2015 even without the influence of the MBR project works.

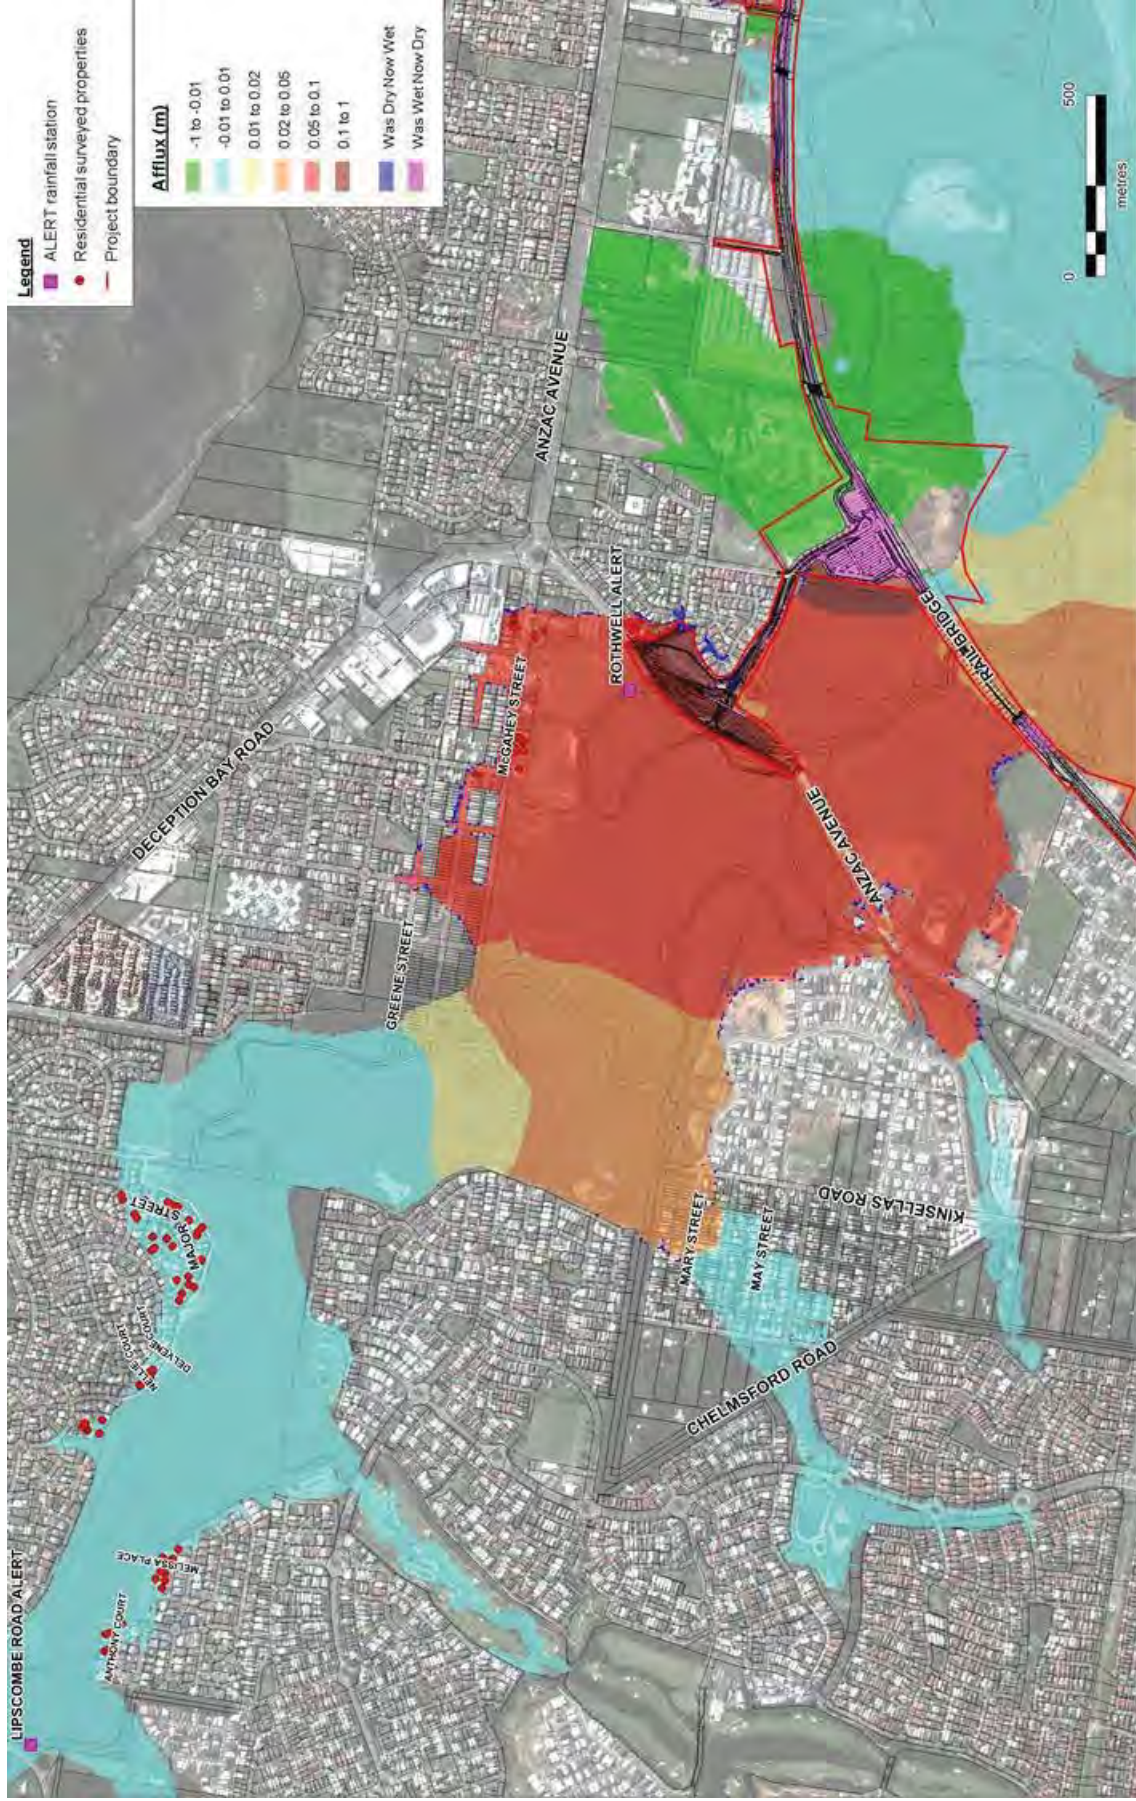
Figure 33 – Afflux, 1st May 2015 event, Developed condition vs. Existing Base condition

Afflux calculated by comparing resulting water levels from the existing base and developed conditions indicate the MBR project works increased the flood levels upstream of project works within the Saltwater Creek catchment during the 1st May 2015 event. The magnitude of the increase varies depending on the location within the catchment and are summarised below:

- There was no increase in flood levels upstream of Greene Street, Rothwell including Major Street and properties further upstream;
- There was an afflux affecting properties at and near Mary Street, Mango Hill. The water level observed was approximately 4.2 mAHD and of this 35 mm can be attributed to the MBR Project;
- There was an afflux affecting properties in McGahey Street, Rothwell. The water level observed was approximately 3.92 mAHD and of this 90-100 mm can be attributed to the MBR Project;
- There was an afflux affecting properties at Anzac Avenue, Rothwell. The water level observed was approximately 3.91 mAHD and of this 90-105 mm can be attributed to the MBR Project; and
- Higher localised affluxes not affecting properties occurred within the downstream section of the floodplain.

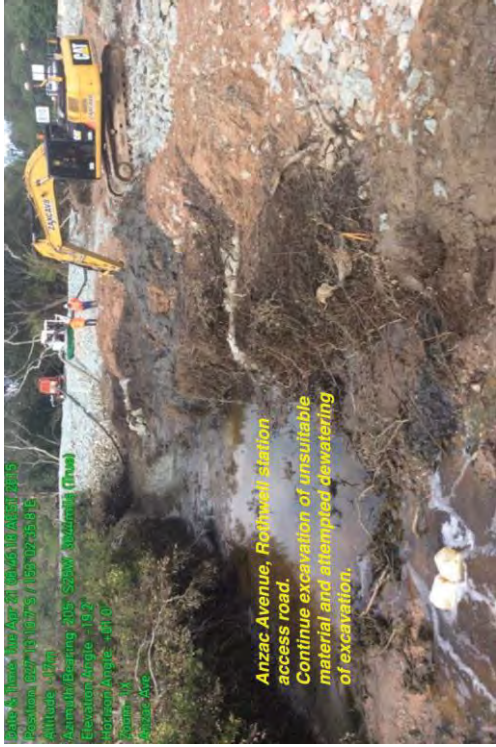
Temporary Works at Anzac Avenue (21/04/2015)

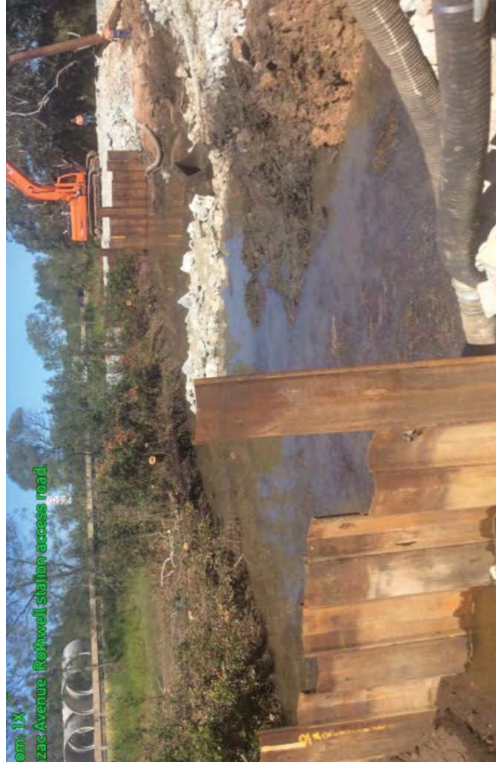
Temporary Works at Anzac Avenue (23/04/2015)
