Moreton Bay Rail Project

Independent Hydraulic Review

Prepared for: Department of Transport and Main
Roads
Date: 7 August, 2015

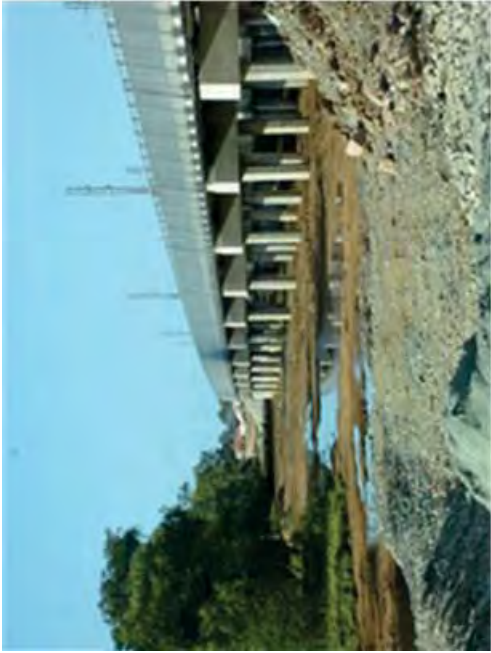
MBR Bridge under construction (25/05/2015)

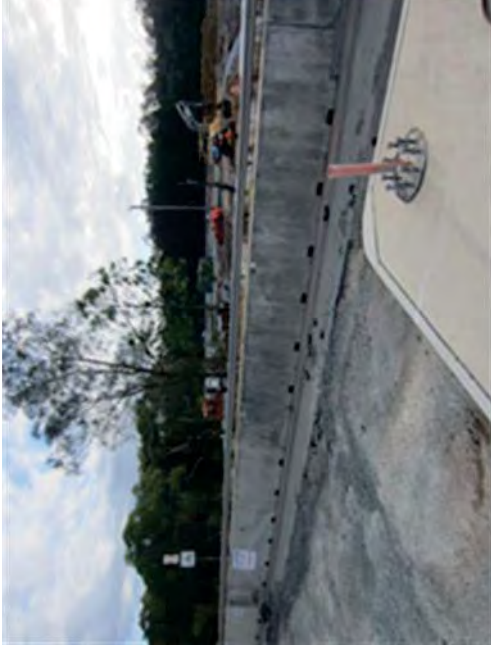
Looking South from Anzac Avenue (25/05/2015)

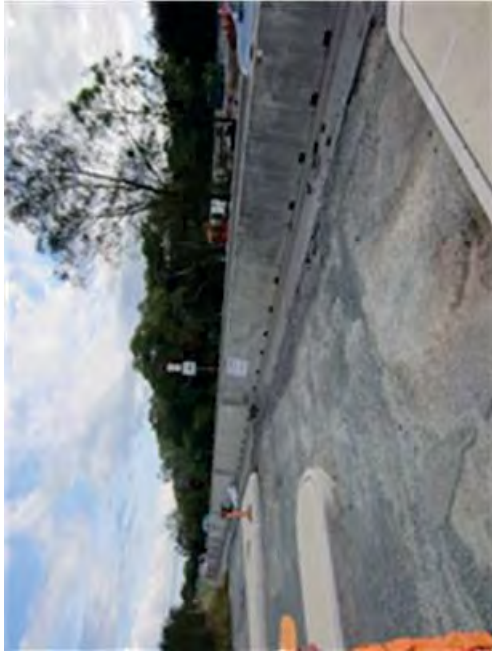
Concrete Barrier along Anzac Avenue (25/05/2015)

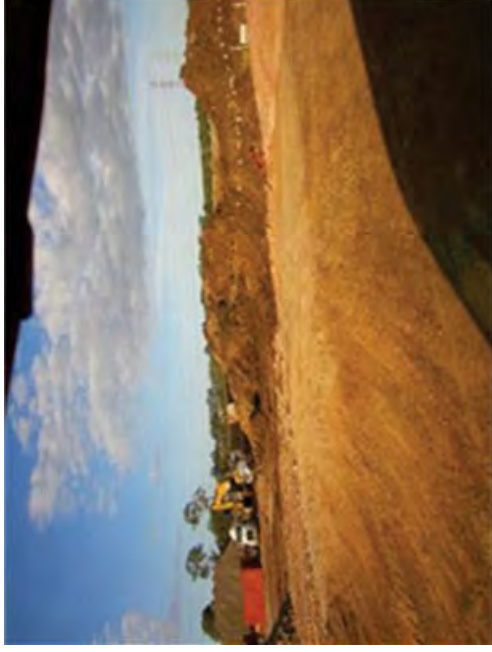
Stockpile near Rothwell Station (25/05/2015)

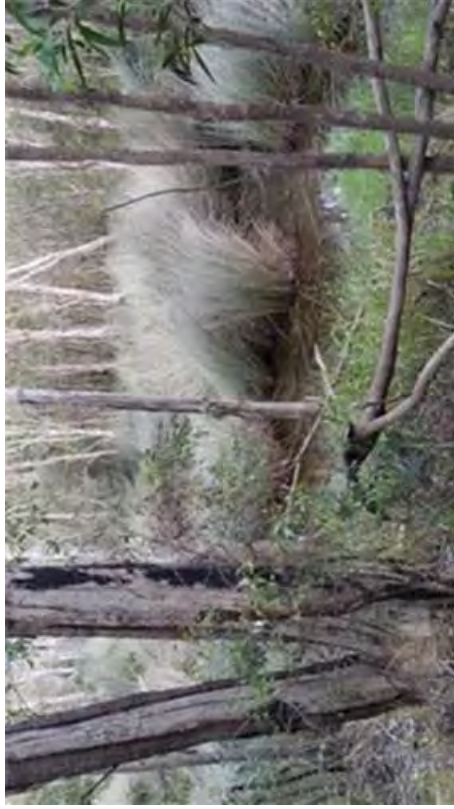
Saltwater Creek near Major Street (16/07/2015)
